# ADRE® for Windows® system detects an unbalance problem on an IP turbine rotor

by Leoncio Nilo P.  
De Jesus

Principal Engineer A,  
Sucat Thermal Power Plant  
National Power Corporation  
Quezon City, Philippines

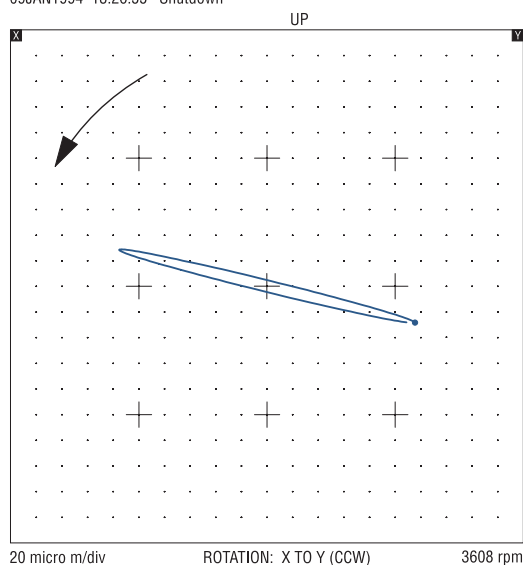
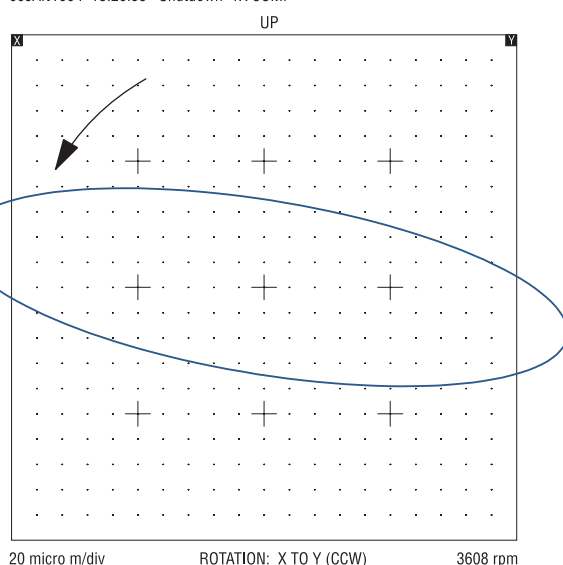
**Figure 2. Shaft orbit plots at bearings 2 and 3, showing high load condition.**

Y: BRG 2 VERT DISP  $\angle 45^\circ$  Left VECTOR: 203 micro m pp  $\angle 180^\circ$  SR: 23.8 $\angle 225^\circ$   
 X: BRG 2 HORZ DISP  $\angle 45^\circ$  Right VECTOR: 123 micro m pp  $\angle 5^\circ$  SR: 28.2 $\angle 341^\circ$   
 MACHINE: HP Turbine  
 09JAN1994 13:26:55 Shutdown

Y: BRG 3 VERT DISP  $\angle 45^\circ$  Left VECTOR: 403 micro m pp  $\angle 24^\circ$  SR: 60.6 $\angle 224^\circ$   
 X: BRG 3 HORZ DISP  $\angle 45^\circ$  Right VECTOR: 305 micro m pp  $\angle 171^\circ$  SR: 73.1 $\angle 345^\circ$   
 MACHINE: IP Turbine  
 09JAN1994 13:26:55 Shutdown 1X COMP

provided valuable clues: it suggested that further realignment on the HP turbine was still necessary and that unbalance was also a contributing factor. Figure 2 clearly shows the flat orbit pattern on bearing 2, indicative of a high load (in this case, the load was externally caused by misalignment between the HP and IP case). The next question was why bearing 3 (IP turbine) was now exhibiting 508  $\mu\text{m}$  (20 mil) pp of radial vibration, when only the HP turbine had been overhauled. Analysis of the collected data indicated that unbalance and misalignment were mainly responsible for these high vibration amplitudes.

Attempts to correct the unbalance condition did not materialize, since the calculations showed that a 3 kg (6.6 lb) correction weight was needed! The machine was thoroughly inspected, and an end-to-end realignment was done. Fortunately, during this realignment, the real cause of this unbalance became apparent.

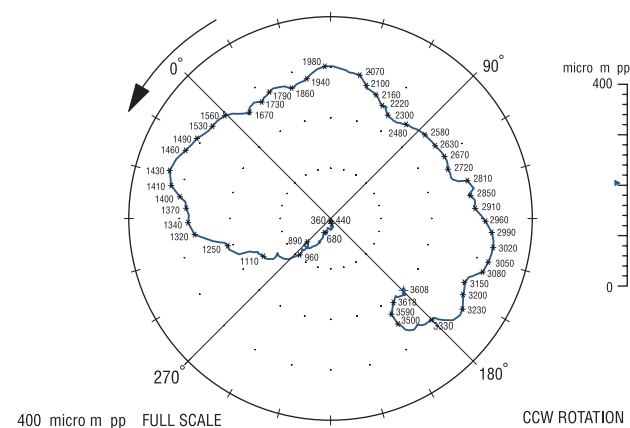
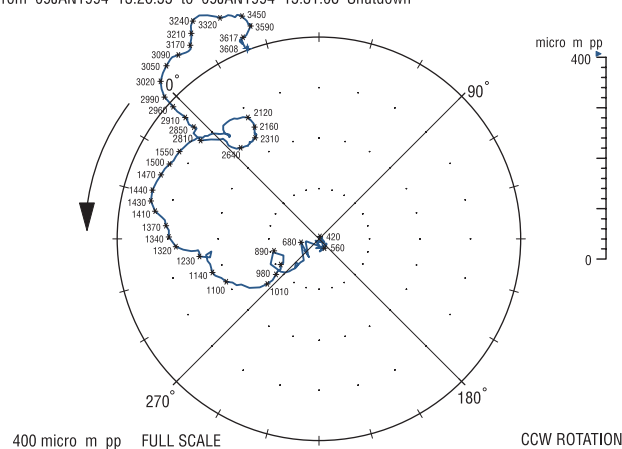
**Figure 3. Polar plots at bearings 2 and 3, after realignment on 9 January 1994.**

The unit was returned to service with its new, partial complement of vibration transducers on 9 January 1994. The vibration data collected by the ADRE for Windows system revealed extremely high shaft vibration amplitudes, reaching 330  $\mu\text{m}$  (13 mil) pp on bearing 2, and 508  $\mu\text{m}$  (20 mil) pp on bearing 3. A unit shutdown was initiated to collect more data for further investigation (Figures 2 and 3).

POINT: BRG 2 VERT DISP  $\angle 45^\circ$  Left 1X COMP SR: 23.8 $\angle 225^\circ$  203 $\angle 180^\circ$  @3608 rpm  
 MACHINE: HP Turbine  
 From 09JAN1994 13:26:55 To 09JAN1994 15:31:08 Shutdown

POINT: BRG 3 VERT DISP  $\angle 45^\circ$  Left 1X COMP SR: 60.6 $\angle 224^\circ$  403 $\angle 24^\circ$  @3608 rpm  
 MACHINE: IP Turbine  
 From 09JAN1994 13:26:55 to 09JAN1994 15:31:08 Shutdown

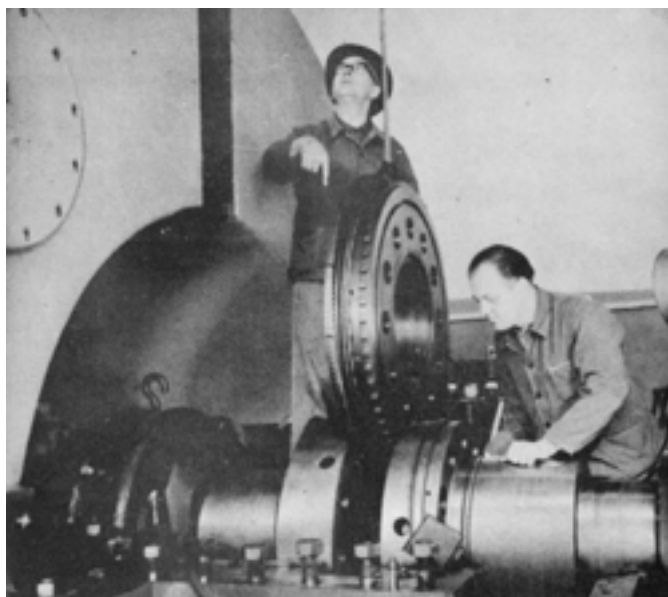
Complete realignment requires uncoupling the shafts and removing the turning gear (located between the IP and LP cases) to verify the axial alignment. When the turning gear was removed, a plug, that should normally reside in the end of the IP shaft, was discovered in the much bigger inner diameter of the turning gear (Figure 4). The plug on the hollow IP turbine shaft allows major inspection for ultrasonic testing. It was determined that the detached plug was the main cause of the excessive unbalance on bearing 3, caused by the tremendous dynamic force created during operation.

**Figure 4. Detached IP shaft plug was found resting on inner diameter of the turning gear.**

The 15.5 kg (34 lb) plug measures 60 mm (2.4 in) thick by 210 mm (8.3 in) diameter.

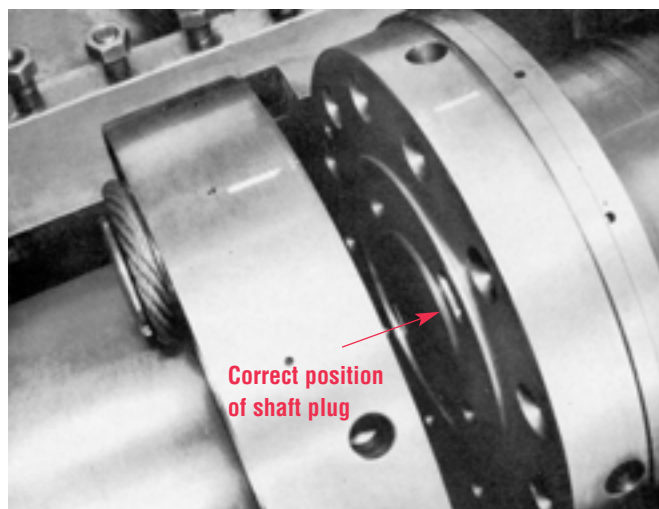
**Figure 5. Plug properly installed in IP shaft.**

The plug was returned to its correct location in the IP shaft (Figure 5), and the unit was placed back online following realignment. The vibration response during load changes was observed and recorded. The ADRE® for Windows® system indicated vibration amplitudes at bearing 3 were at normal levels. Bearings 2 and 9, however, exhibited high 1X vibration, and examination of the data indicated this was from an unbalance. A field balance was scheduled to reduce the vibration amplitudes at these bearings. The data collected during transient and steady-state conditions was used to determine the amount and locations of the correction weights. The correction was carried out simultaneously on bearings 2 and 9, since no cross-effect from each correction weight was expected.

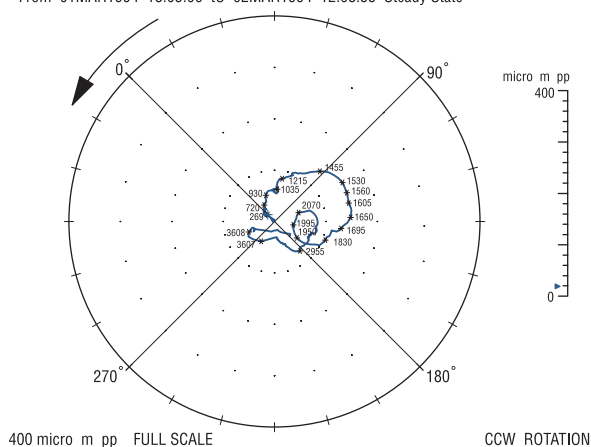
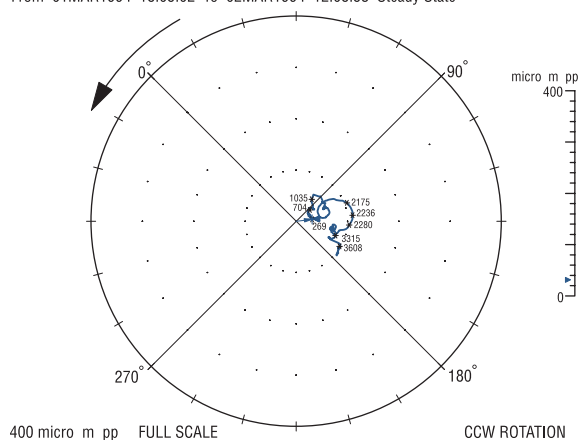
**Figure 6. Polar plots of response at bearings 2 and 9 during startup after the initial balance correction.**

The initial correction weights reduced the 1X vibration amplitudes, as seen in the polar plot responses from the horizontal probes at bearings 2 and 9, respectively (Figure 6). The next field balancing attempt, made by repositioning the correction weights, was successful in reducing the vibration on bearings 2 and 9 even more. The unit was placed back

POINT: VB2 VERT  $\angle 45^\circ$  Left 1X COMP SR:  $0\angle 0^\circ$  (man) 18.8 $\angle 0^\circ$  @269 rpm  
 MACHINE: IP Turb O/B  
 From 01MAR1994 18:05:06 to 02MAR1994 12:08:55 Steady State

POINT: VB9 VERT  $\angle 45^\circ$  Left 1X COMP SR:  $0\angle 0^\circ$  (man) 31.3 $\angle 128^\circ$  @269 rpm  
 MACHINE: Exciter O/B  
 From 01MAR1994 18:05:02 To 02MAR1994 12:08:53 Steady State
